AIAA 96-0486

Electrostatic Charging of the Pathfinder Rover

34th Aerospace Sciences Meeting & Exhibit

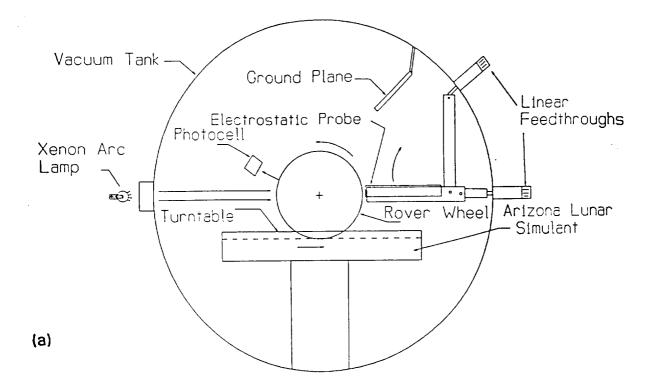
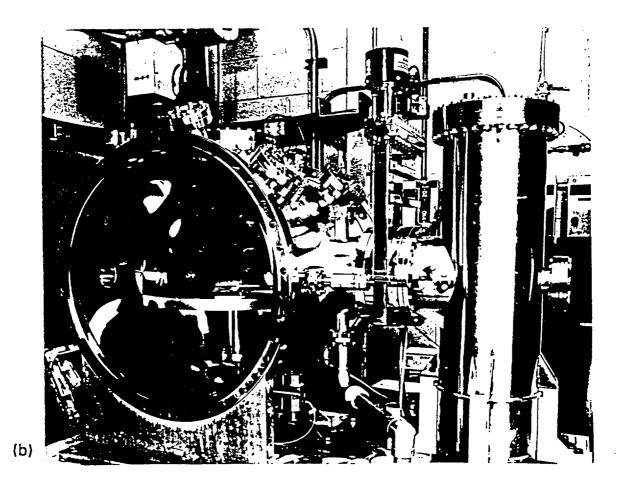
Figure 1: Schematic (a) and photograph (b) of test facility

A Mars simulator facility had already been set up to conduct tests for the Wheel Abrasion Experiment (WAE, Ref. 5). This facility was adapted to examine the problem of electrostatic charging. A capacitively coupled electrostatic probe was installed, and tests were run with a simulated Mars surface atmosphere and Arizona Lunar Simulant (ALS). Experiments were conducted with two different wheels, hereafter referred to as the test wheel and the System Integration Model (SIM) wheel. The test wheel was a crude mock-up of the rover wheel, made to approximate dimensions. The SIM wheel was a more detailed model of the flight wheel. Both were driven at typical rover speeds. Charging was found to occur.

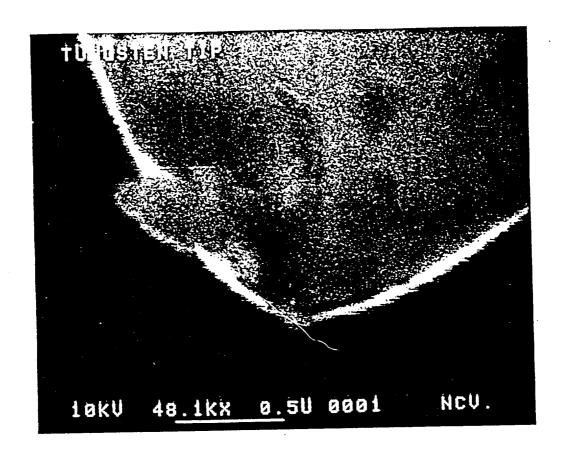
Figure 2: Electron microscope photograph of tungsten discharge point (scale on photo)

Two different wheels were used: the test wheel and the SIM wheel. Two types of discharge points were attached to each of the wheels: a 12.7 μm radius stainless steel wire cut at the end, and a tungsten wire electromachined at its end to a point of radius 1 μm (Fig. 2).

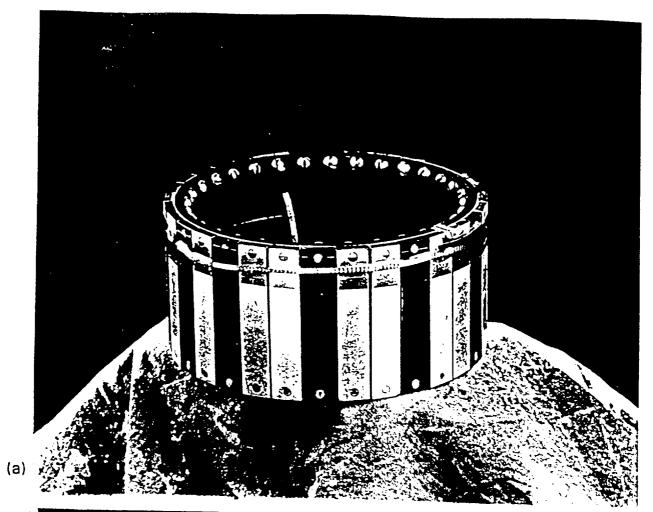
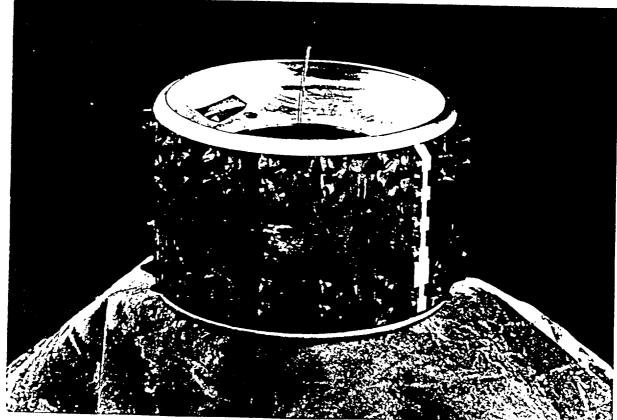
Figure 3: Test Wheel (a); SIM Wheel (b)

For the test wheel, the 12.7 µm stainless steel point and the tungsten point were soldered to a braided copper wire. The braided copper wire was wrapped around the wheel and held down with Kapton tape. The braided copper wire with the discharge point was brought to the wheel axle, and extended outward 5 cm. (Fig. 3).

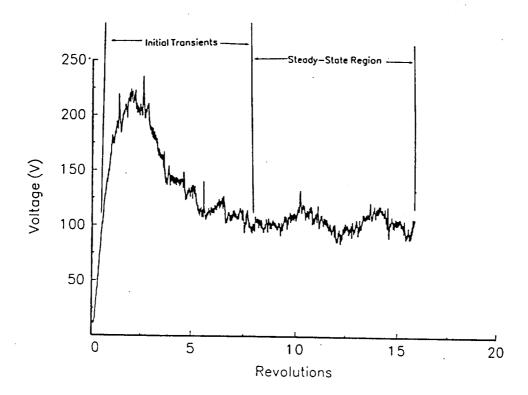
Figure 4: Typical plot of test wheel potential as a function of number of revolutions (0.7 rpm, 500 gm load, ALS, 7 mbar martian atmosphere)

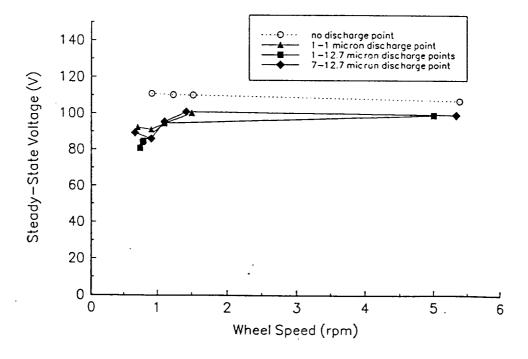
Figure 5: Dependence of test wheel steady state potential on type of discharge point (500 gm load)

Comparison of the steady-state potentials with no discharge point, a 12.7 µm stainless steel discharge point, and the tungsten point are shown in figs. 5. Each of the two types of points produced about the same reduction in voltage. Increasing the number of 12.7 µm radius stainless steel points from 1 to 7 gave no further reduction in potential.

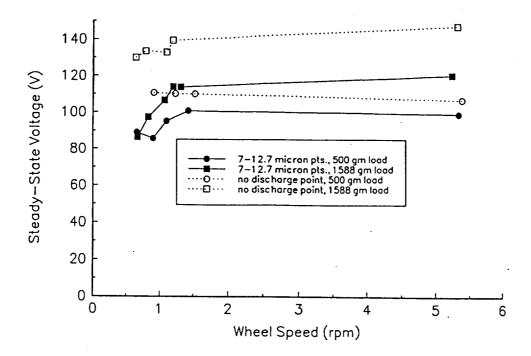
Figure 6: Dependence of test wheel steady state potential on load and type of discharge point

The effects of wheel loading and of adding a discharge point to the wheel are shown in Fig. 6. A wheel with a load of 500 gm and seven 12.7 µm radius stainless steel discharge points shows a reduction in steady-state potential by 14%¹ over a wheel with no point at comparable speeds. Retaining the seven points on the wheel, and increasing the wheel load from 500 gm to 1588 gm produced an increase in steady state potential by 16%. With no discharge point, increasing the wheel load from 500 gm to 1588 gm increased the steady state voltage by 25% at similar speeds.

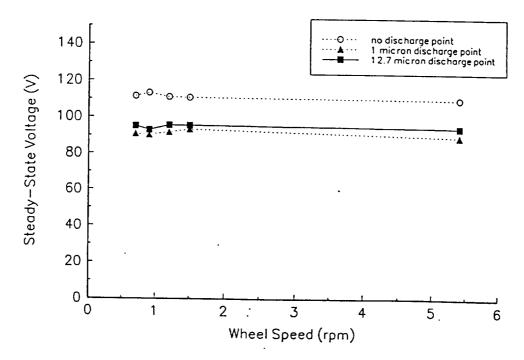
Figure 7: Dependence of SIM wheel steady state potential on type of discharge point (500 gm load)

The steady-state potentials of the test wheel, with 500 gm load, no discharge point, a 12.7 µm stainless steel point, and a tungsten point are shown in Fig. 7. The initial voltage transient of the wheel may be as large as three times the steady-state voltage. The reason for this transient is not clear. A chamber related effect might be the most reasonable first assumption. But since demonstrating rover charging possible mitigation schemes were the primary objectives of these tests, and since time was short, a good deal of additional science was left undone.

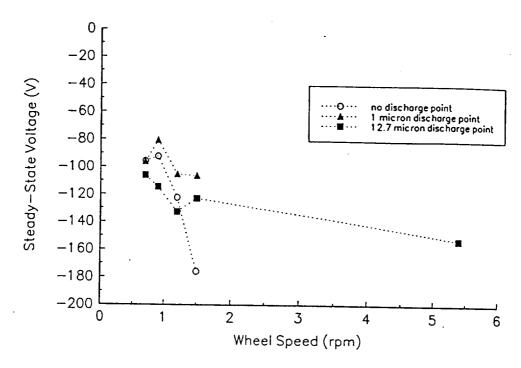
Figure 8: ALS potential with SIM wheel and different discharge conditions

The negative charge left behind by the SIM wheel after its passage over the ALS measured with the was electrostatic probe appropriately repositioned. This charge was recorded for all three point configurations of points (above), and different wheel speeds. Results are shown in Fig. 8. The charged negatively dust approximately the same absolute value of potential as the wheel. Grain size measurements (see below) showed that small grains adhered to the wheel, large grains did not. The negative values of the ALS potential reveal the charge separation between these differently sized grains.

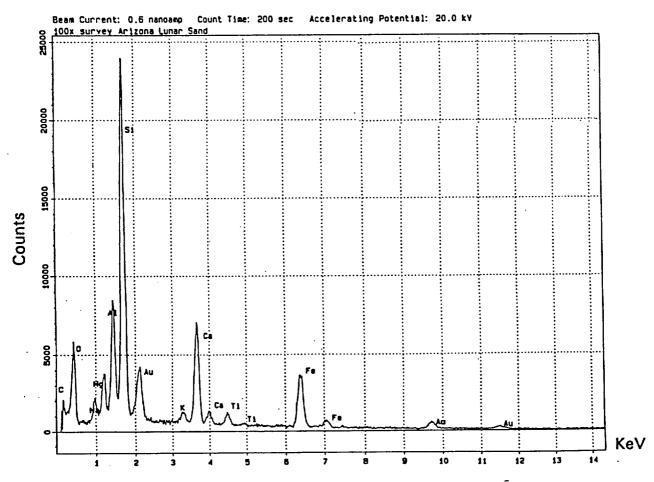
Figure 9: Energy Dispersive X-Ray Analysis of ALS

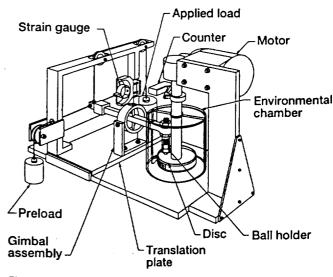
Fig. 1-Pin-on-disk tester.

The pin-on-disk tribometer used in this study, shown in Fig. 1, has been described in detail in Ref. (14). The specimens consisted of a flat rotating disk (6.3 cm diameter) in sliding contact with a stationary pin (ball) (0.476 cm radius) which was securely fastened in a holder. The ball slid on disk tracks that ranged from 4.8 cm to 3.7 cm in diameter. The rotational speed of the disk was controlled at 200 rpm giving linear sliding speeds of 0.50 to 0.39 m/s. The test specimens were encased in a plastic box to control the atmospheric humidity. A load of 2 kg was applied to the ball, which gave an initial maximum contact stress of 1.3 GPa (190,000 psi). A polyethylene ring was fastened around the diameter and extended approximately 0.4 cm above the surface of the disk to restrain the oil from being thrown from the disk by centrifugal forces. The amount of oil used for each test was 2 g.

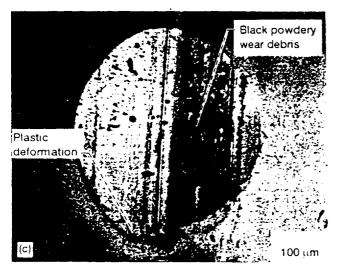
Fig. 5—Comparison of ball wear scars after 2 km of sliding.

- (a) silane emulsion
- (b) silane disk coating
- (c) no sllane treatment

A comparison of the ball wear surfaces after 2 km of sliding is shown in Fig. 5 for the following tests: a silane emulsion, a silane disk coating, and no treatment. For both the silane emulsion and silane coating tests, a much smoother wear scar was obtained and FTIR analysis indicated a deposit of silane was adhering to the wear scar. The ball scar from the test with no silane treatment showed a very rough surface, much more black powdery wear debris and some plastic deformation of the scar in the exit region.

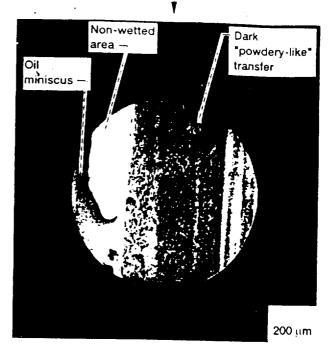
Fig. 8—Photomicrograph of a ball wear scar after 266 km of sliding from a test where no silane emulsions or coatings to the disk were employed. Dewetting of the oil from the surface can be observed.

Figure 8 shows a photomicrograph of a ball wear scar after 266 km of sliding where no silane emulsions or coatings to

the disk were employed. Dark powdery transfer is observed as well as an area where the oil is not wetting the surface. It is not certain why this phenomena occurred, but this dewetting phenomena has been observed using the PFPE lubricants on other occasions by the authors. The dewetting phenomena was not observed for any test in which silane was used as an additive or as an emulsion.

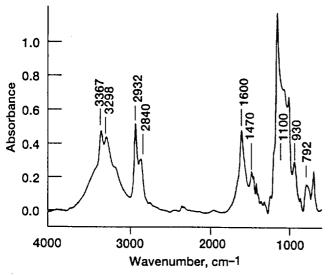
Fig. 11—FTIR spectra of a silane coating applied to a 440C stainless steel disk.

To ascertain if silane were transferred from the emulsion or coating to the mating surfaces, a µFTIR spectrum of the silane coating was taken before testing and then compared to deposits on the ball wear surfaces. Figure 11 shows the μFTIR spectrum of the silane coating applied to a 440C steel surface. The two sharp bands at 3367 and 3298 cm⁻¹ are typical N-H asymmetric and symmetric stretching vibrations which occur in NH2 groups. The band at 1600 cm-1 is the corresponding deformation vibration. Hydrogen bonding is typical in the solid or liquid state for compounds containing NH₂ groups. Thus, hydrogen bonding accounts for the broad peak between 3000 and 3500 cm⁻¹. Since this film has been baked after its application to the 440C surface, it is unlikely that this broad vibration would be due to H-bonding of hydroxyl groups. Other peaks present are the C-H stretching vibrations due to the C₂H₅ and the C₃H₆ groups which appear at 2840 and 2932 cm⁻¹, respectively. The band at 1470 cm⁻¹ is the corresponding deformation vibration. The Si-O-C₂H₅ vibrations appear at 1100 and 930 cm⁻¹ and the Si-C₃H₆ appear at 792 cm⁻¹.
